RE: Golden State Metals
EPA ID Number CAD982489809

ABBREVIATED PRELIMINARY ASSESSMENT REPORT

Site Information: Golden State Metals
2000 East Brundage Lane
Bakersfield, CA 93387
Latitude 35° 21' 18" Longitude 118° 58' 08"

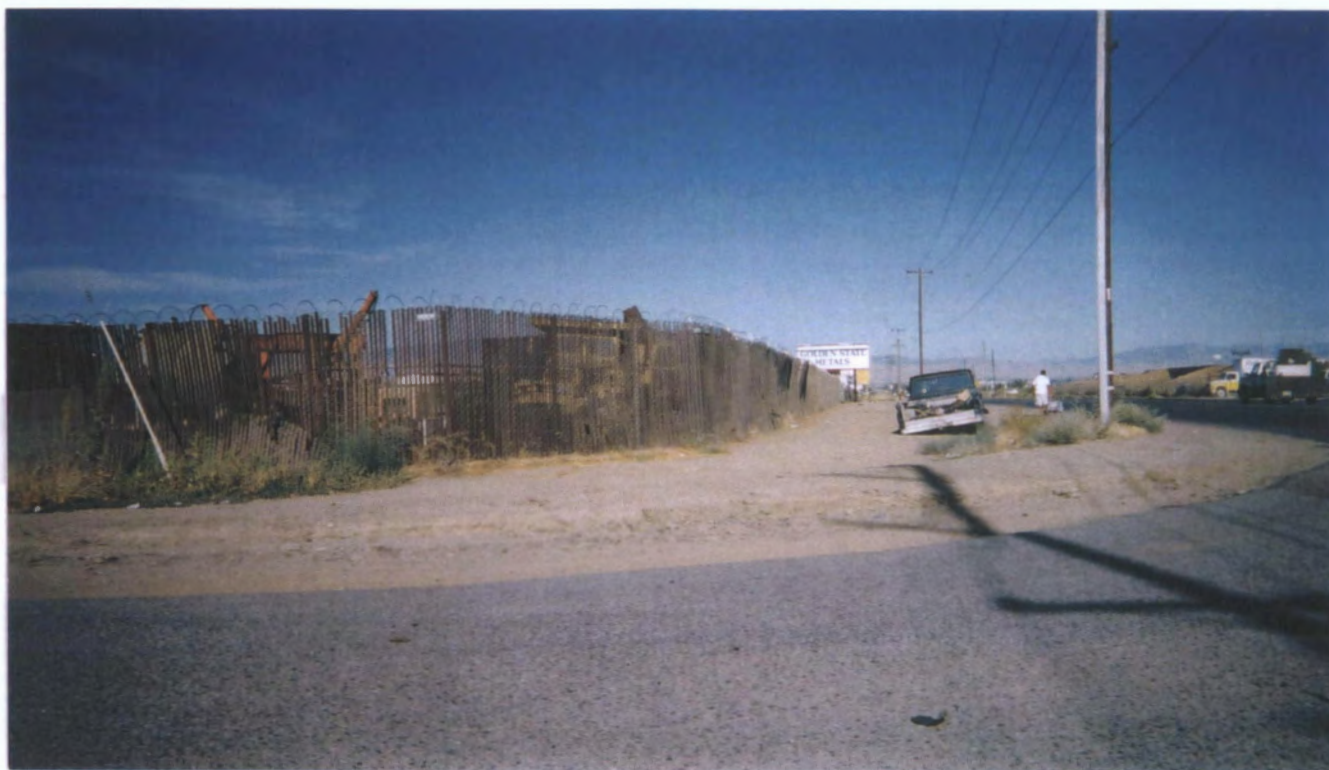
Photograph #1. View of southwest corner of property along East Brundage Lane.

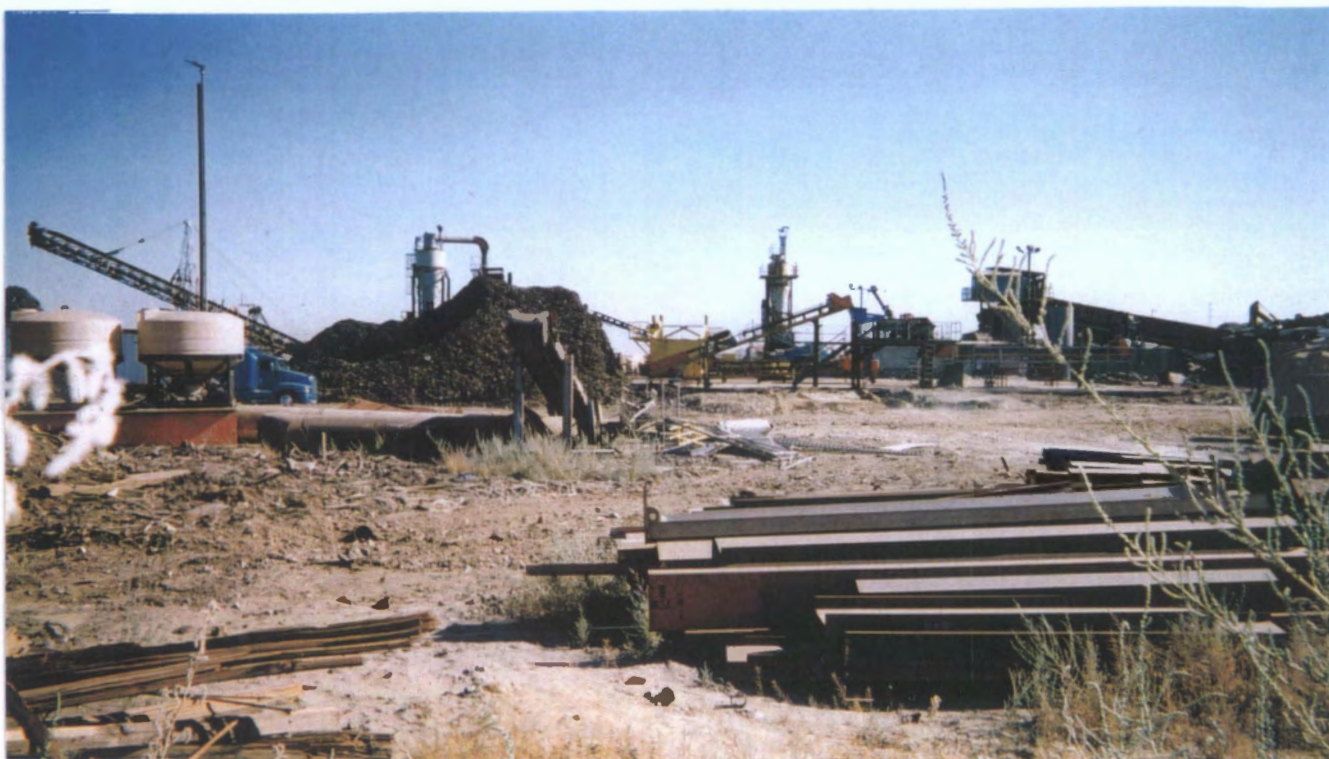
Photograph #2. View of facility from north end. Notice pile of ASW on left.

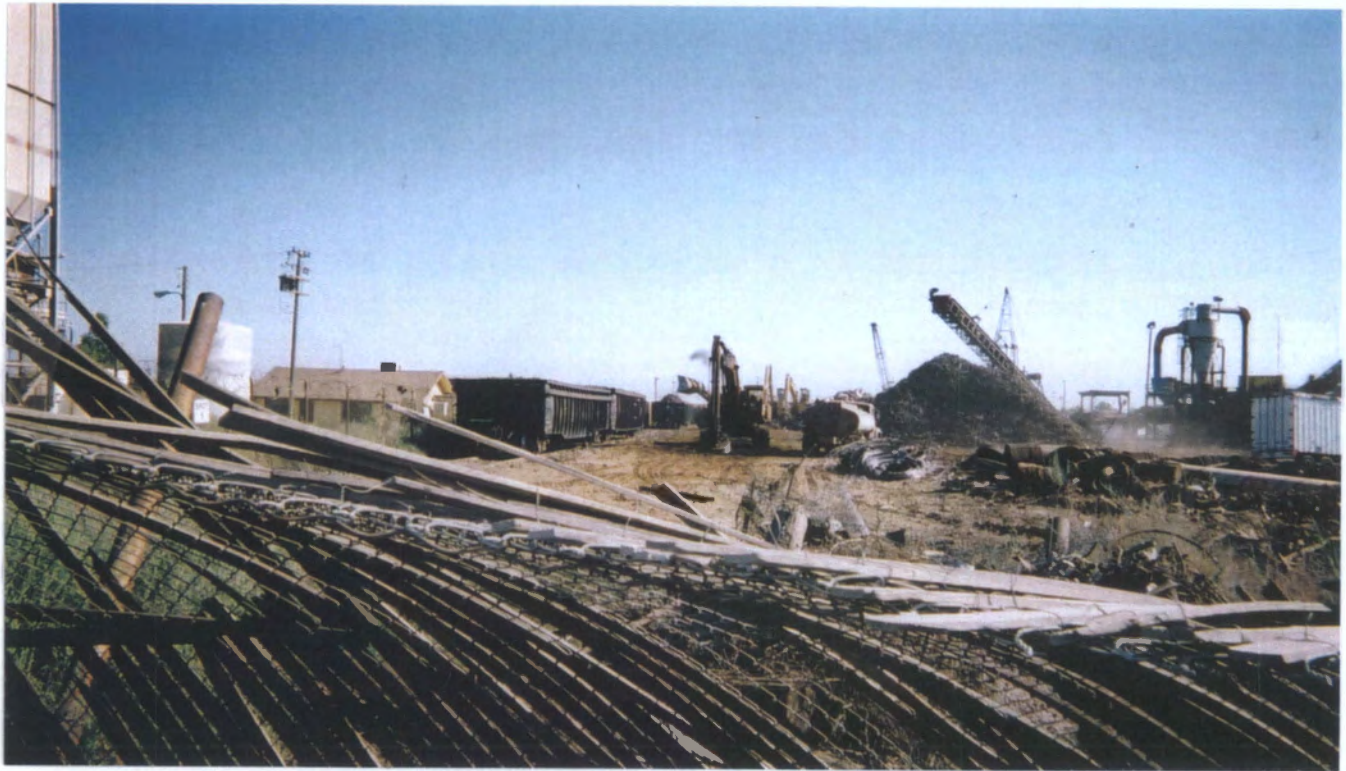
Photograph #3. View from northeast corner of property. Notice loading of ASW into train cars in background.

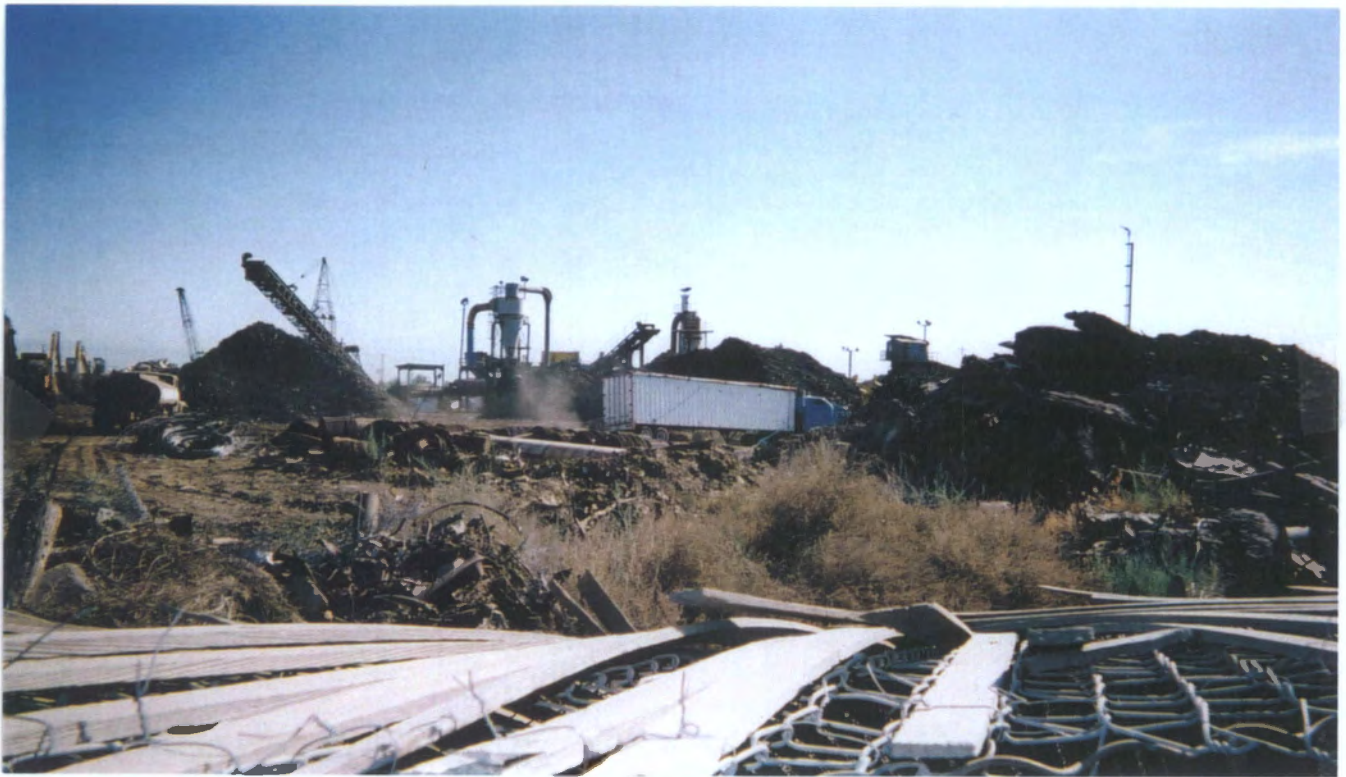
Photograph #4. View of scattered debris at north end of property.

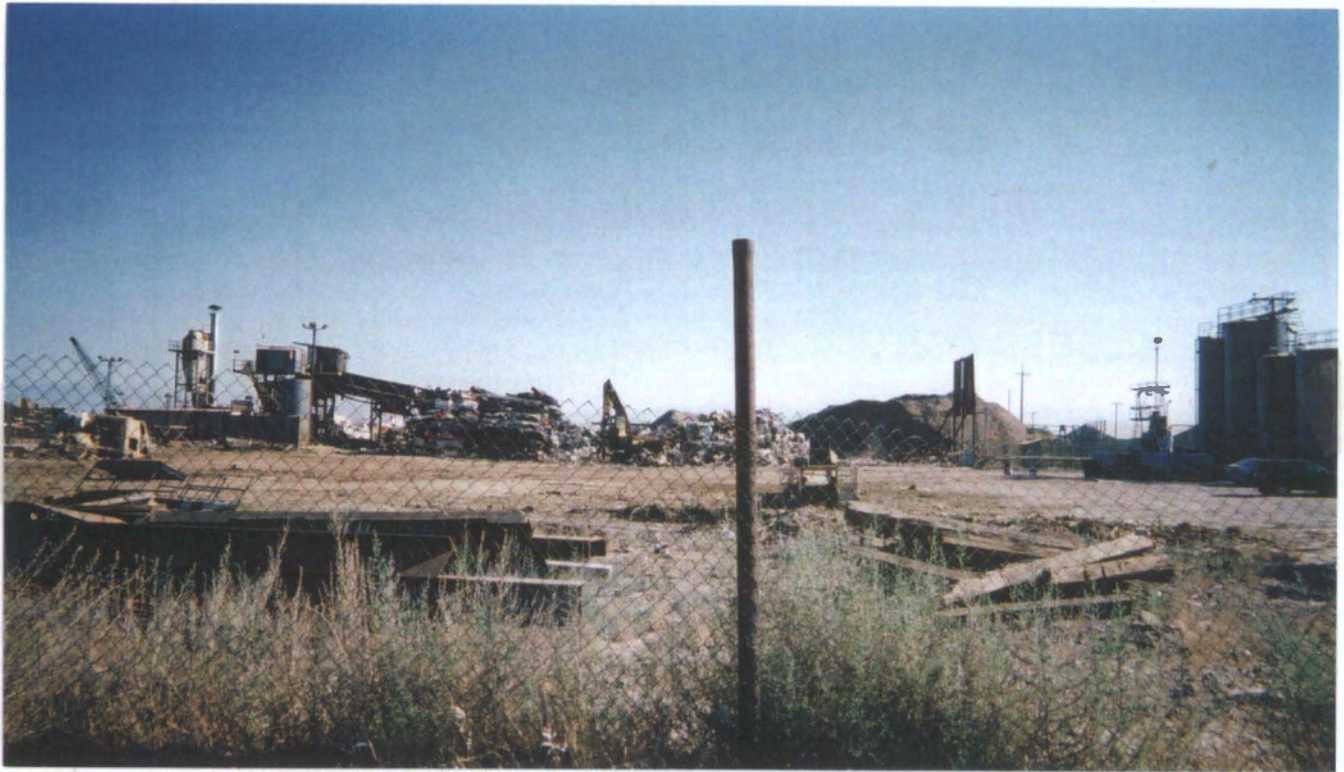
Photograph #5. From left to right: View of auto shredder conveyor and autos to be shredded. ASW in background.

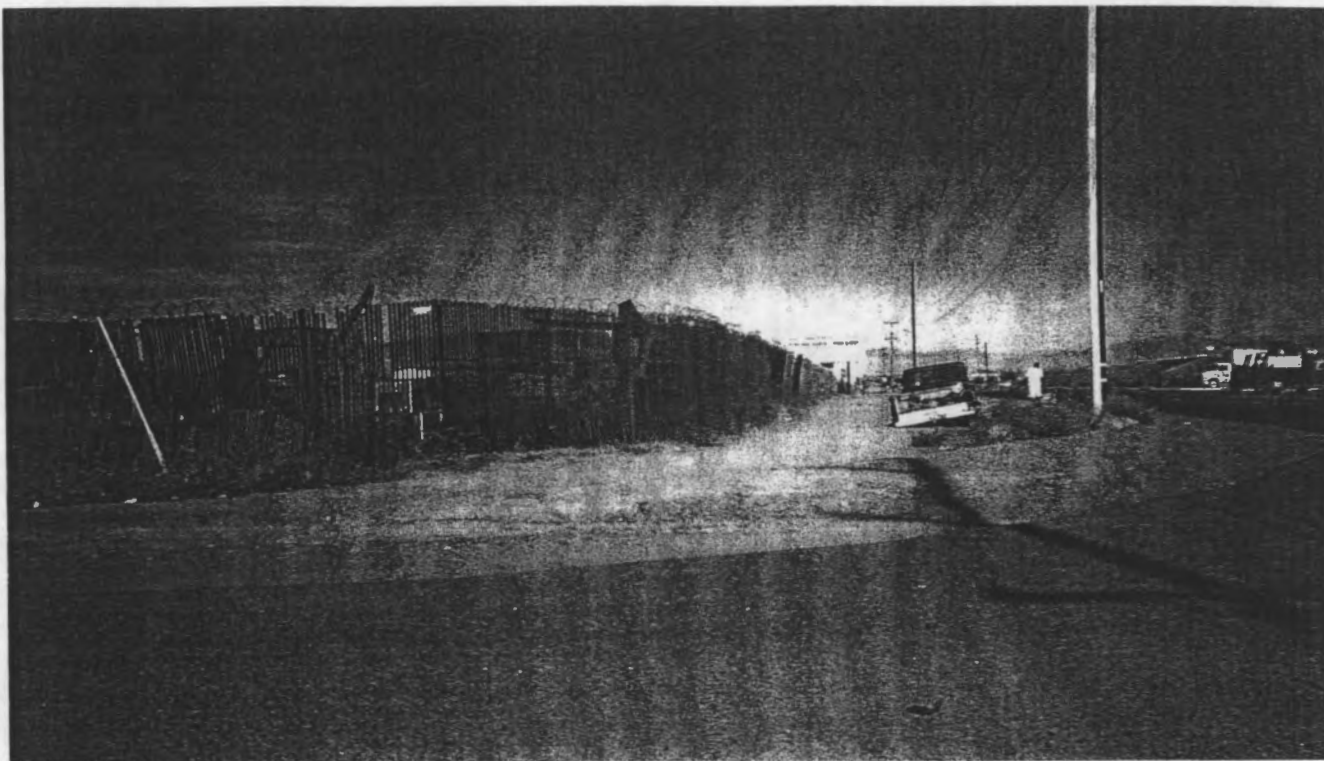
Photograph #1. View of southwest corner of property along East Brundage Lane.

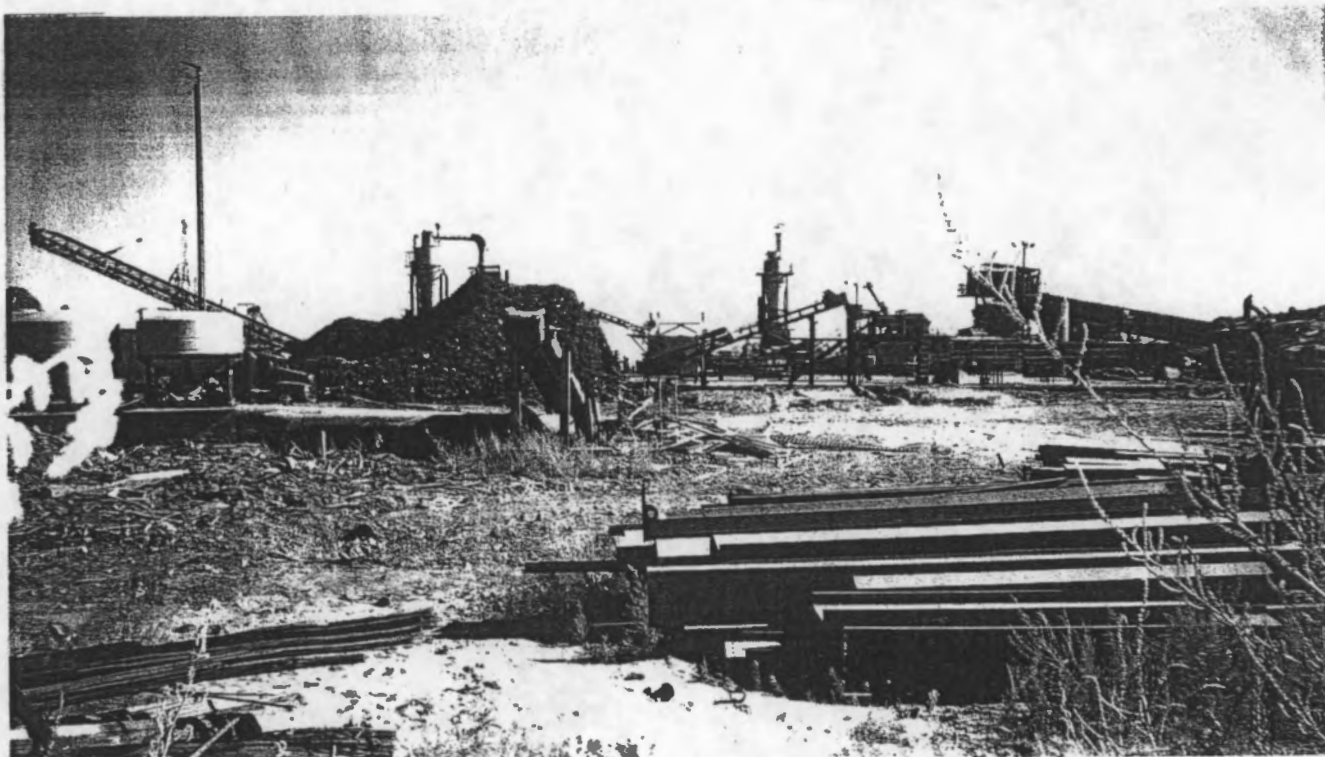
Photograph #2. View of facility from north end. Notice pile of ASW on left.

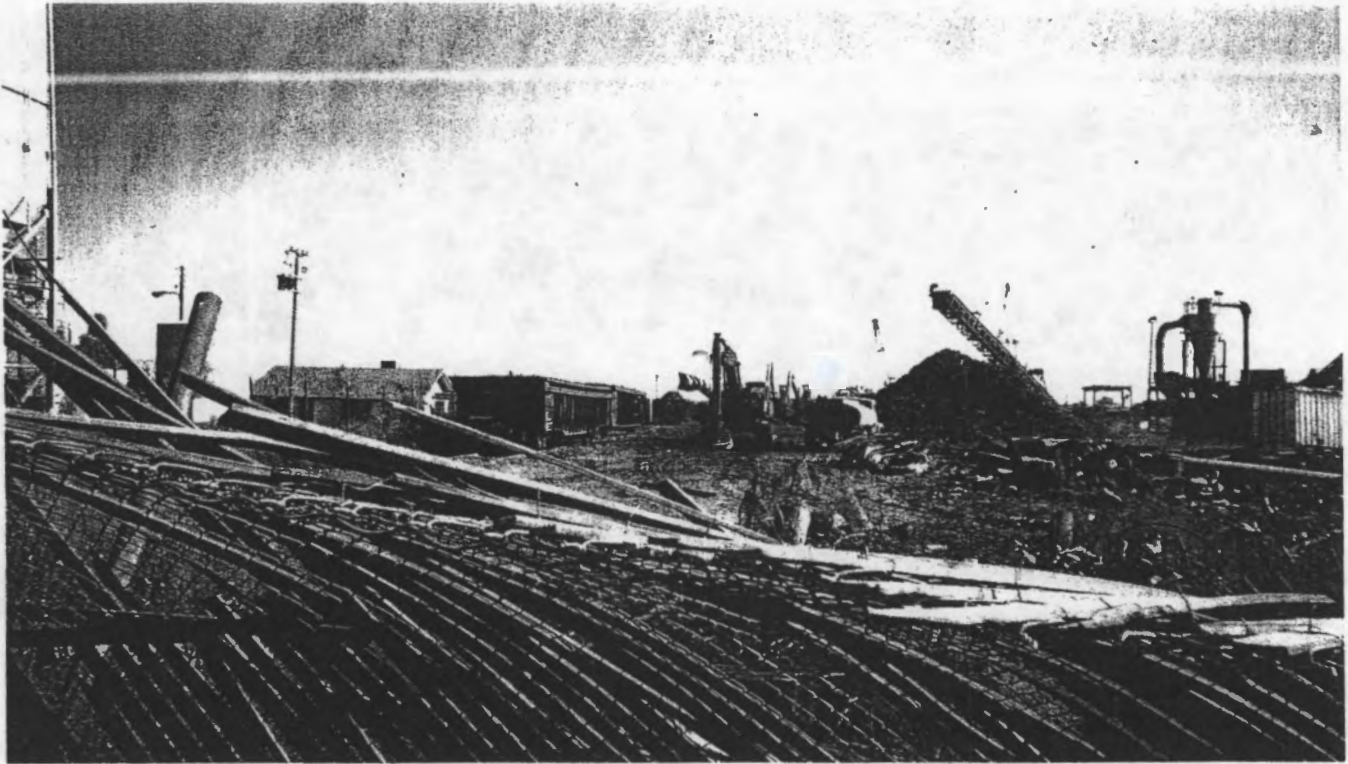
Photograph #3. View from northeast corner of property. Notice loading of ASW into train cars in background.

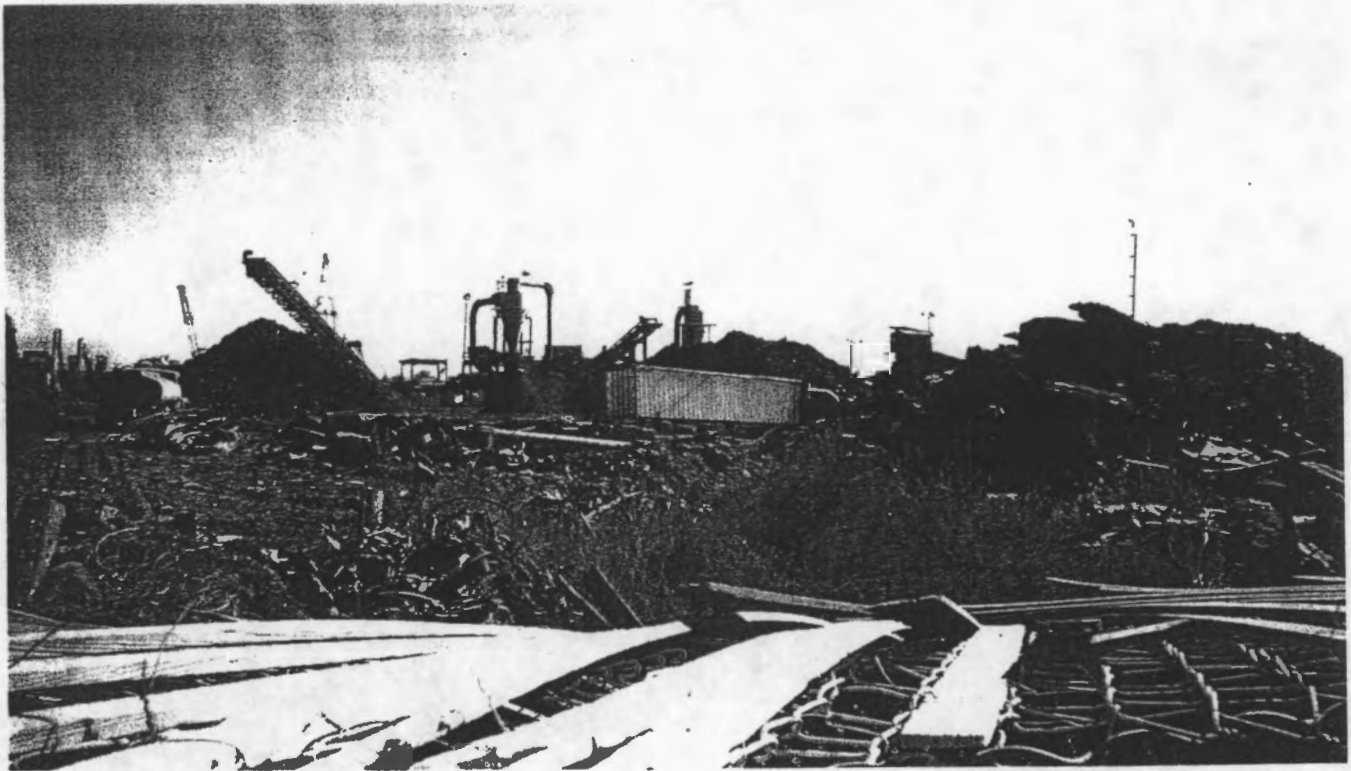
Photograph #4. View of scattered debris at north end of property.

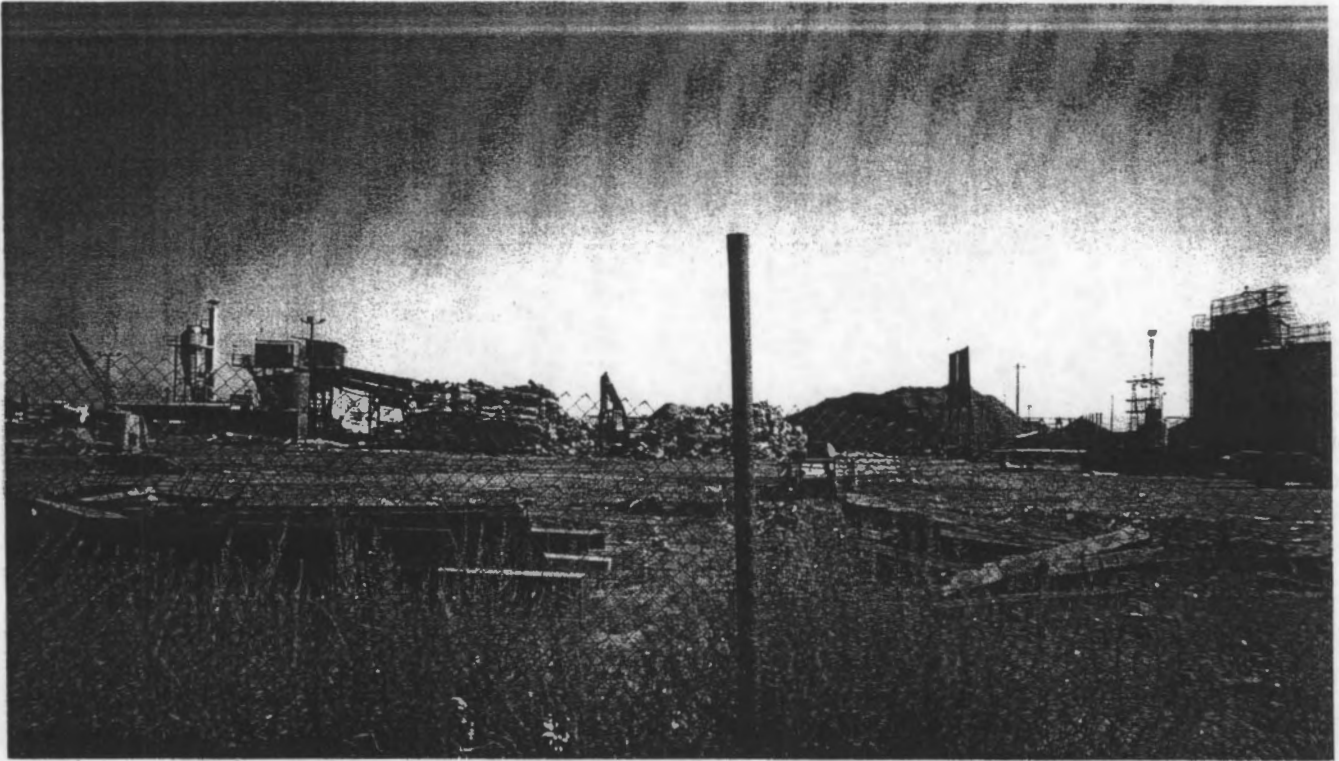
Photograph #5. From left to right: View of auto shredder conveyor and autos to be shredded. ASW in background.
